R ESEARCH HIGHLIGHT

Technical Series 06-100

PERFORMANCE EVALUATION OF THE ALMON STREET MULTI-UNIT RESIDENTIAL BUILDING

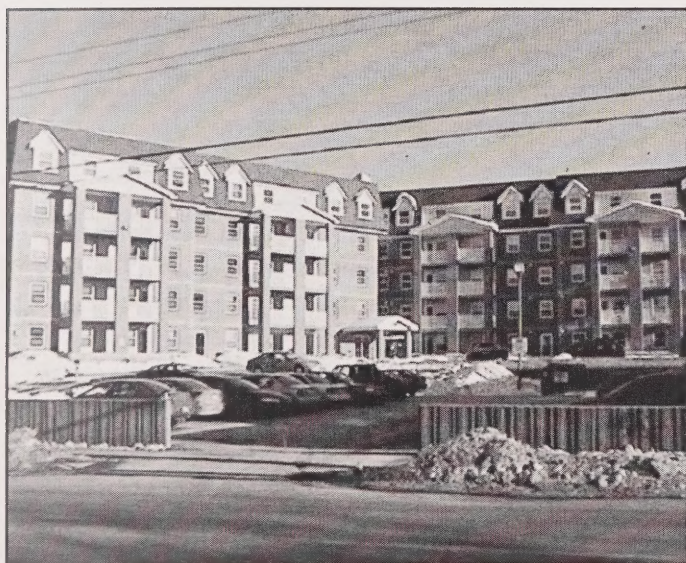
Figure 1: The Almon Street Building

The building is a fully sprinklered, wood-frame five-storey building with a floor area of 6,604 m² (71,060 ft²) and an underground heated garage with an area of 1,250 m² (13,443 ft²). The building (Figure 1) contains 60 apartments housing a mix of families, singles and elderly persons. The apartments on the 4th floor are two-storey units making up the 4th and 5th floor levels.
